## Optimization of Ball Diameter

HONDA Civic VIII

**GSP Part Number:** S080075, S080076

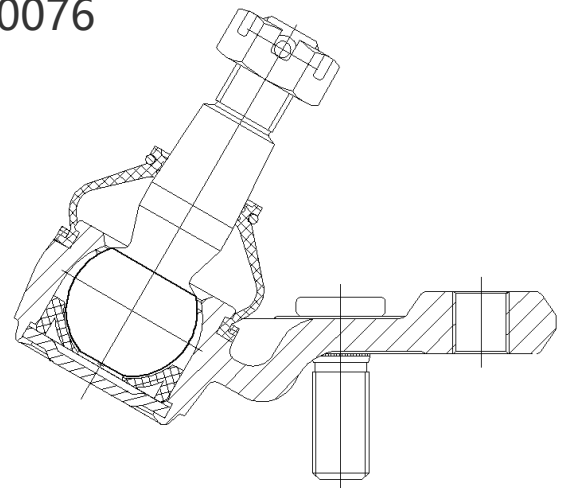
British customers reported that the ball joint was unstable in operation and vibrated during steering, which affected the service life of the product.
